Lesya Chen^{1*}, Natalia Yavna²

Architectural and Artistic Features of the Entrance Portal of the Church in Velykyi Khodachkiv of Ternopil Region

Architectural Studies, 8(1), 63-70

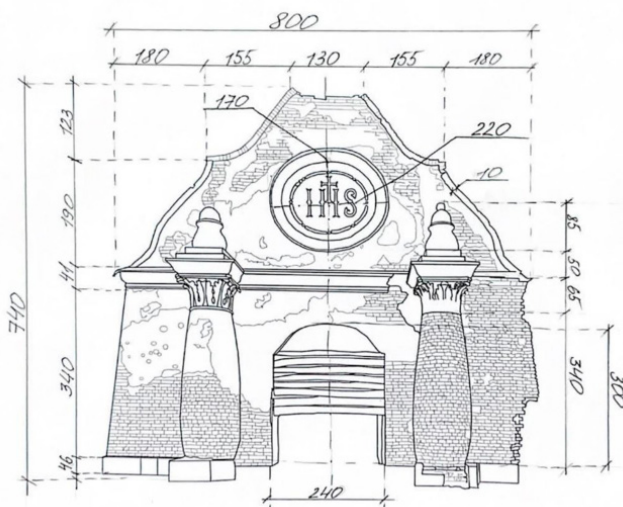
Figure 1. Dimensional drawing of the portal

In the process of the research of the main portal of the Church of the Mother of God in Velykyi Khodachkiv, general scientific (empirical – observation, survey, description, theoretical – analysis, systematisation, comparison, generalisation) and special professional research methods (morphological (stylistic) analysis, conservation, restoration, field surveys, and photogrammetric fixation) were used [6]. Using these research techniques, the authors identified the causes of the object's soaking, which led to the destruction of portal fragments, peeling of plaster, loss of part of the cornice, and potholes in the brick (Fig. 1).

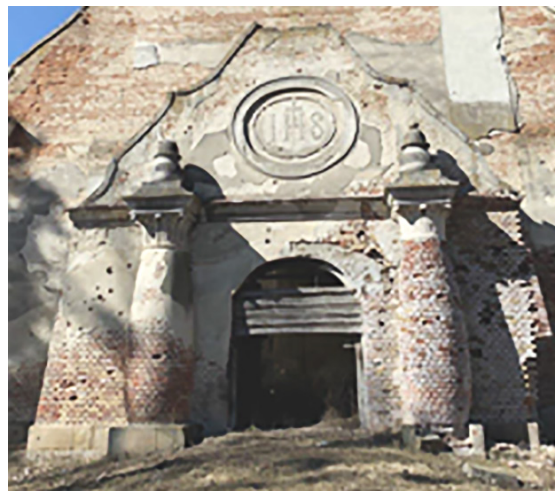
Figure 3. The main portal of the church in Velykyi Khodachkiv

In the course of field surveys, the authors discovered that the portal has serious mechanical damage, namely: loss of plaster along the entire portal, weathering of stone on the reliefs of the capitals, lost parts (the upper decorative element on the vase-shaped part on the left side, the lower part of the right side of the portal, and the top of the portal) (Figs. 1, 6). The cornice on the right side has considerable damage and losses. The entire portal suffered partial losses of bricks, potholes, and damage to masonry joints. As a result of soaking, cornices of capitals and vase-like acroteria are covered with micro-sprouts of bioorganisms (lichens). The door to the main arched entrance is completely lost. The entrance to the church is laid in the upper part with several wooden planks. It should be emphasised that in the decoration of the portal, an equally important role was assigned to the decoration of doors, made of solid wood.

Restoration measures were developed and the following types of priority works were proposed to preserve the monument:

- conducting conservation and restoration of brickwork;
- cleaning of the outer surface from dirt, efflorescences, and destructive layers;
- filling hollow cracks in brickwork;
- structural strengthening of brick surfaces with special mortars, putty of chips and fixing minor losses, restoration of masonry joints;
- biocide treatment;
- tinting sections of inserted bricks;
- protective treatment of the monument surface, hydrophobisation of the portal.

In case of losses of brickwork for structural strength, it is allowed to supplement using bricks. The process of strengthening and complementing the material structure should be accompanied by the use of natural materials that are compatible with authentic ones. Injection of cracks should be conducted after the completion of work on replacing losses, putty, and fixing emergency areas. Restoration of masonry joints must be conducted with solutions as close

as possible to the original ones. Plastering requires a strong surface that has been cleared of destructive mortar. Plastering of chips is performed on the surface of the brick, which has a depth loss of less than 3 cm, with deeper losses, the brick must be completely or partially replaced. For this, a lime-sand mortar that is as close as possible to the brick surface in texture and colour must be selected [11]. Biocidal treatment of brick surfaces is conducted in the summer, eliminating all sources of moisture, in the absence of precipitation.

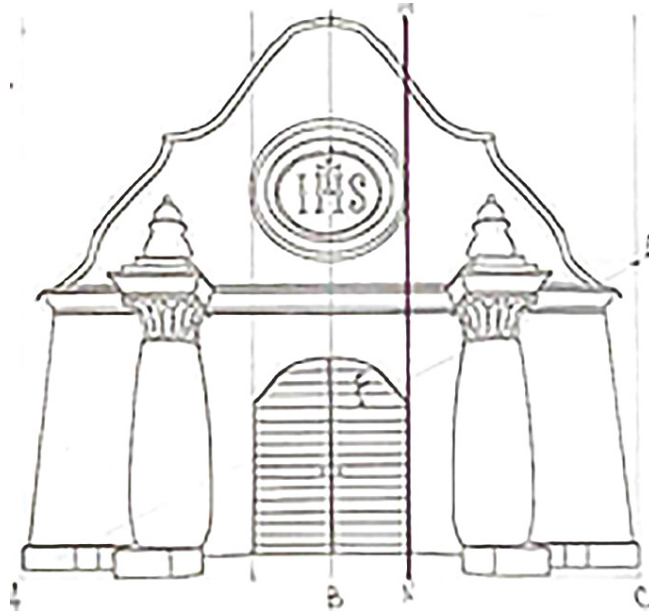
The basis of proportional portal construction is a system of rational simple relations: the ratio of width to height of the portal is 1:1 (Figs. 1, 5), that is, its composition fits into a square, respectively, the basis for building the portal is based on the principle of the Golden Section [3] (Fig. 5). When designing the portal, not only the general proportions and ratios of their individual parts, mainly the load-bearing

and finishing parts, but also the ratio to the size of the church itself were particularly important [7]. When measuring the object under study, the authors discovered that the ratio of the height of the portal to the height of the church is 1:2, and its width to the width of the church is 1:1.5. The classical proportions of the Corinthian order Capitals to columns are 1:10 [8], and in this case, it is 1:6 (Fig. 1).

Figure 5. Portal proportions $BC=CD$; $CD=DF$; MN – golden section
