CONSERVATION OF ARCHITECTURAL AND ARTISTIC HERITAGE

**CAUSES OF DESTRUCTION
OF ARCHITECTURAL DETAILS MADE OF ALABASTER STONE.
(FOR EXAMPLE, THE GOTHIC CHURCH IN DROHOBYCH)**

The aim of this study is to define the reasons and the consequences of the deterioration of the gothic alabaster portal of the parish church of St. Bartholomew in Drohobych.

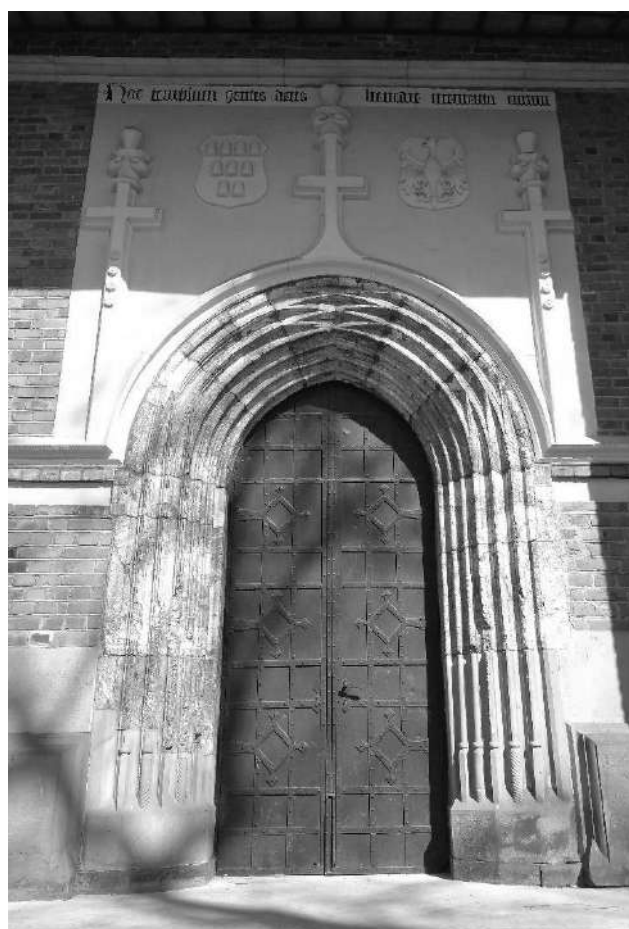
Fig. 4. Drohobych, parish church, south portal, 2018

The gothic alabaster portal of the Church of St. Bartholomew in Drohobych is in the extremely unsatisfactory condition. Internal, small, large, deep cracks are visible all over the alabaster surface. Mechanical loading causes an increase in their size, depth and quantity. Rain, water, humidity, abrupt air temperature change leads to the formation of furrows, cavities, splits, weathering and stratification of the alabaster. Stratification can be mostly observed on the masonry wall of the church. The stone surface is uneven and loose, covered with black patina. There are also yellow, white and red-orange spots. Cracks, cavities, additions, masonry joints between the blocks, gaps are filled with cement mortar. The additions belong to different periods. A big gap across the plane between the portal jamb and the metal door is also filled with cement mortar. It indicates the fact that the entrance door was much closer. The additions of the jamb are partly green and black. There are also spots of red paint. Cement mortars used during the additions differ from each other by the ratio of binding agent and component composition: brick, sand, gypsum, lime. There are gypsum additions on the portal (gypsum without fillers, gypsum mixed with fibers, found between 7–8 blocks) and gauged mortar (the filler of which is crushed brick) in the joints between the blocks.

Numerous alabaster panels of different size, colour, structure and period of mounting, which were the results of the previous restoration work, are on the portal. The alabaster panels are fixed on the cement mortar. Most of the panels are in the unsatisfactory condition. The keystone of the portal is in a particularly critical condition, as the biggest amount of mechanical loading falls on it.

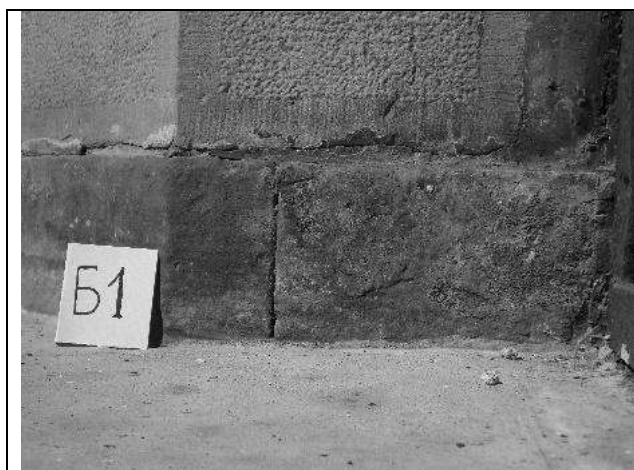
Block No. 1

Four stone rectangular planes, which follow the angle of the portal, are made of sandstone. The surface finish of the stone looks like a bush-hammered plane with fluted arrises. The block was hewn of sandstone.

State: stable

Losses: 90 % of the face finish is lost

Deterioration: weathering, small splits

Cracks: two deep cracks, which can lead to chipping off the substantial part of the block

Contamination: black patina, yellow and white spots, which can cause dampness of the stone

Additions: joints between the blocks and the wall filled with cement mortar. One of the block planes is inserted as a separate slab, which can be a result of the previous restoration work

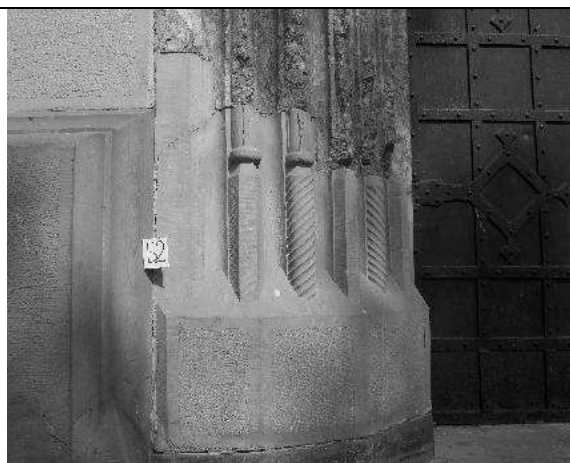
Block No. 2

Result of the restoration work: Block №2 looks like four square planes with a transition to the corrugated body of the portal. Molding profile of the ribs resemble an astragal. There are six ribs. The bead moldings have a prismatic and curved form. The square planes of the block have a bush-hammered decoration with fluted arrises. The block is hewn from sandstone.

State: satisfactory

Losses: not detected

Deterioration: stone weathering, small splits and cuts

Cracks: one large crack in the stone, which can lead to chipping off the substantial part of the block. The crack follows to the lower part of the block, jointed with cement mortar. Between the cement mortar additions and the stone small cracks appeared, one of which was jointed with cement over again.

Contamination: spots of black and red paint, little orange pots like spots of rust, white smudges

Additions: a gap between the block and the entrance door filled with cement mortar and partly painted in green colour.

Panels: not detected

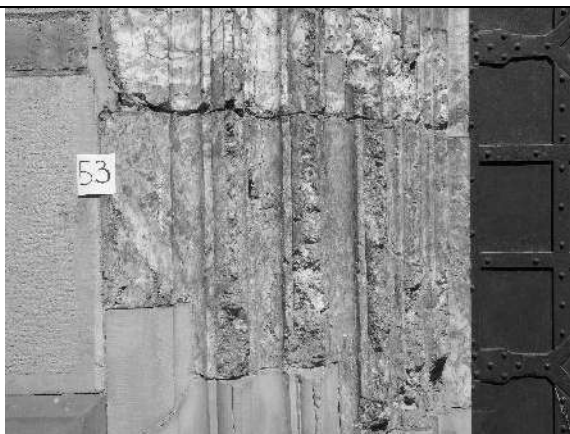
Block No. 3

Alabaster molding block, consists of five ribs.

State: unsatisfactory

Losses: lower part of the 1, 2, 3 ribs of the portal

Deterioration: on the most part of the stone's surface (80%) erosion caused by wind, water erosion, temperature change can be observed, which resulted into the formation of numerous cuts, cavities, splits, minor and large cracks. Marks of mechanical cleaning of the stone: deep even furrows all over the plane.

Cracks: minor, small, large

Contamination: yellow, red, white spots; spots of black and red paint

Additions: a gap between the block and the entrance door filled with cement mortar and partly painted in green colour. The joints between the blocks and the wall are filled with cement mortar.

Panels: jamb of the portal of yellow alabaster with grey veins

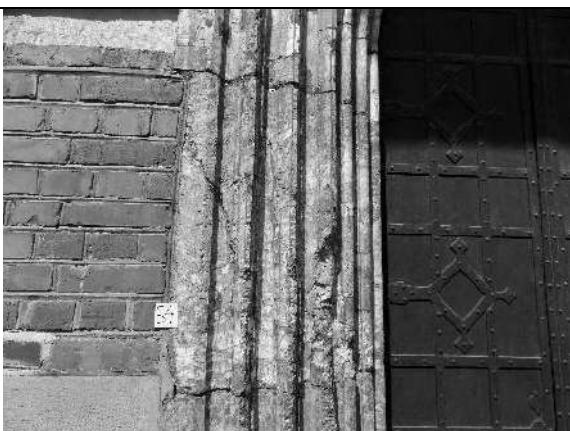
Block No. 4

Alabaster molding block, consists of five ribs.

State: unsatisfactory

Losses: significant part of portal ribs lost its initial form. A part of the third rib is completely lost.

Deterioration: on the most part of the stone's surface (80 %) erosion caused by wind, water erosion, temperature change can be observed, which resulted into the formation of numerous cuts, cavities, splits, minor and large cracks. Marks of mechanical cleaning of the stone: deep even furrows all over the plane.

Cracks: two deep cracks, which can lead to chipping off the substantial part of the block; numerous small and internal cracks

Contamination: there are splashes of black and red paint on the internal side of the portal; green cement addition, black patina

Additions: 11 panels of yellow and grey alabaster. The state of panels is stable. Between the block and the entrance door there is a gap all over the height of the block filled with cement mortar

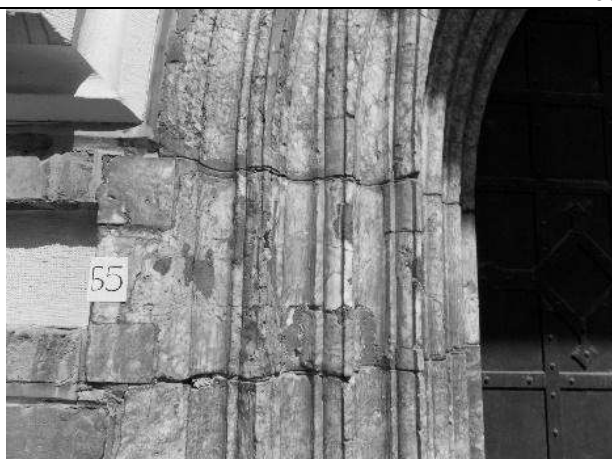
Block No. 5

Alabaster molding block, consists of five ribs.

State: unsatisfactory

Losses: a part of the yellow alabaster panel chipped off

Deterioration: erosion on the surface of the stone; the surface is uneven and rough, entirely covered with cavities, furrows; there are marks of coarse sandpapering of stone

Cracks: seven large deep cracks, which can lead to chipping off the substantial part of the block. Numerous minor, small and internal cracks.

Contamination: there are spots of black and red paint on the internal side of the portal; green cement addition, black patina

Additions: Six cement mortar additions. Between the block and the entrance door there are a gap, joints, cracks, cavities filled with cement mortar

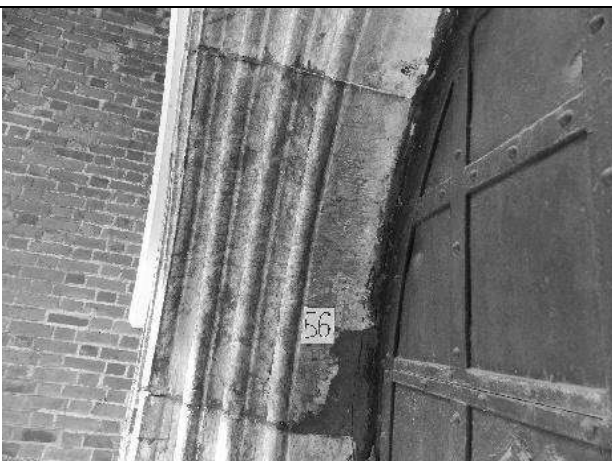
Block No. 6

Alabaster molding block, consists of five ribs and intersecting crossings to the next block.

State: unsatisfactory

Losses: part of the fifth molding

Deterioration: erosion of the surface of the stone, numerous cavities, cracks, furrows, and the surface is uneven and rough. There are flat horizontal furrows on the jamb of the portal. They are supposedly the marks of the tool, which remained after the stone dressing.

Contamination: there are spots of black and red paint on the internal side of the portal; green cement addition; black patina; yellow, white and orange spots; on the jamb surface of the portal lime or gypsum mortar was detected.

Additions: Between the block and the entrance door there are a gap, joints, cracks, cavities filled with cement mortar. Cement additions are also on the ribs of the portal.

Panels: five alabaster panels

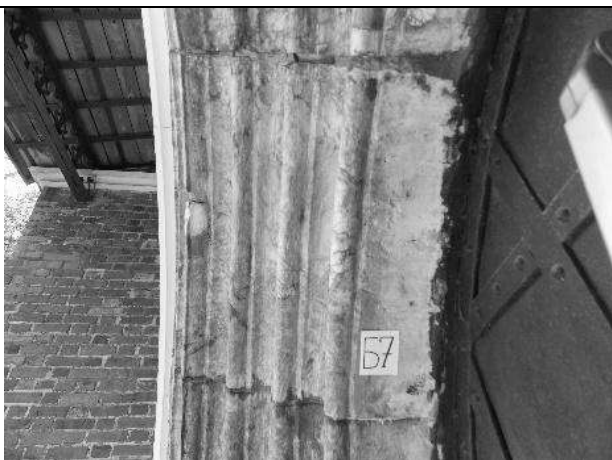
Block No. 7

Rounded block consists of seven ribs. Profile of the ribs has a bead molding shape.

State: unsatisfactory

Losses: not detected

Deterioration: mechanical deterioration – splits, erosion of the surface of the stone, numerous cavities, cracks, furrows

Cracks: three large cracks, which can lead to chipping off elements of the block

Contamination: most of the surface of the stone is covered with yellow spots, splashes of cement mortar; jamb of the block is rubbed with gypsum mortar

Panels: six alabaster panels of different colour

Additions: there is an addition of gypsum and cement mortar on the fourth rib. The crack on the third rib is filled with cement. Between the block and the entrance door there is a gap all over the height of the block, joints

<p>between the blocks are filled with cement mortar. There is a sample of two kinds of cement mortar with different content of impurities between the seventh and the eighth blocks, which can be a result of the restoration work in different periods</p>
--	---

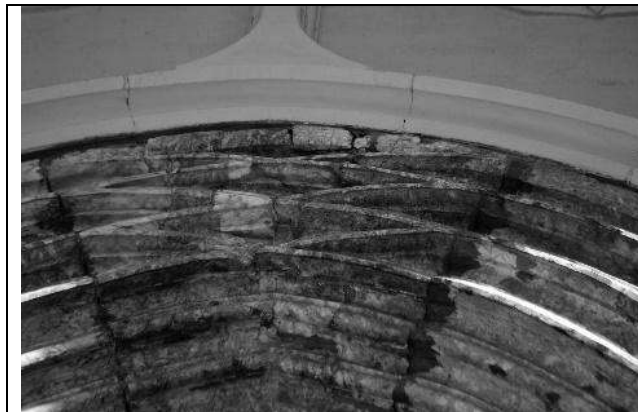
Block No. 8

Keystone of the portal with intersecting ribs, which create a diamond pattern.

State: unsatisfactory

Losses: part of the ribs at the intersection of the fourth row of ribs

Deterioration: mechanical deterioration – splits, erosion of the surface of the stone, numerous cavities, cracks, furrows; the stone is uneven and rough. There are deep furrows, which can be a result of the mechanical cleaning with metal brushes

Cracks: deep cracks between the alabaster panels and the authentic stone, deep crack on the second rib, which can lead to chipping off most of the block, numerous small cracks.

Contamination: splashes of cement mortar, yellow spots, black patina. Part of the cement additions between the block and the entrance door is in black, red and green paint.

Panels: ten alabaster panels of different colour – yellow, white, grey – fixed on the cement mortar. There is an inserted wood peg between the fifth and the sixth rib, polished as a profile shape.

Additions: cracks, joints between the blocks, a gap between the block and the entrance door filled with cement mortar

The fourth reason is mechanical loading, which results into the formation of deep and large cracks. The biggest loading falls on the upper keystone part of the portal, which is now in the critical condition.

These factors can be the reason to the portal collapse. There is an urgent need for its restoration.

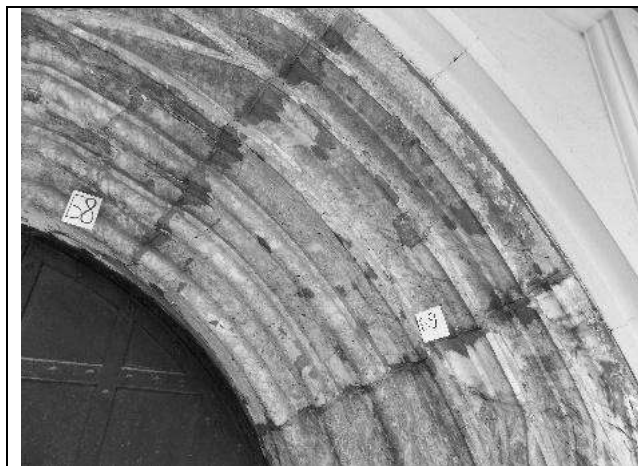
Block No. 9

Rounded block consists of seven ribs. Profile of the ribs has a bead molding shape.

State: stable

Losses: small piece of the sixth block is lost

Deterioration: deep flat furrows are cut horizontally on the jamb of the block in a chaotic order; there are also numerous furrows on the surface of the stone, which can be a consequence of the mechanical cleaning with metal brushes. Erosion of the surface of the stone, numerous cavities, cracks, furrows, and the stone is uneven and rough. The jamb of the block is far whiter than the natural colour of the stone, the reason of such state of the stone is unknown.

Cracks: four deep cracks, numerous minor and small cracks. There are also cracks in the cement addition between the block and the entrance door.

Contamination: yellow spots, black patina. A part of the cement additions between the block and the entrance door is in black, red and green colour.

Panels: three alabaster panels

Additions: numerous minor additions of cement mortar on the ribs of the block; also, on the entire surface near

the junction of the eighth and the ninth block, between the jamb of the portal and the entrance door a gap is filled with cement mortar
--	---

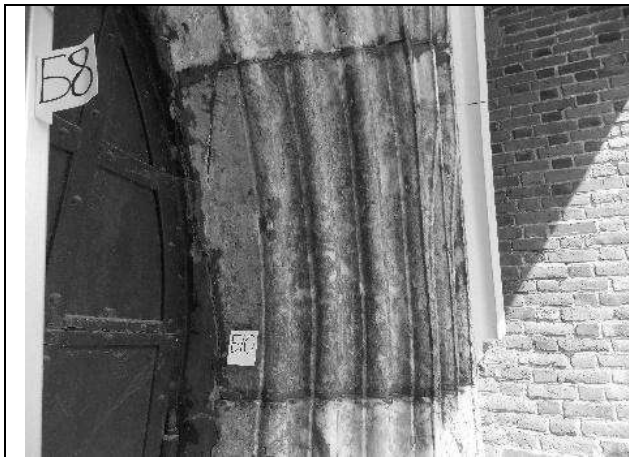
Block No. 10

Alabaster molding block, consists of five ribs and intersecting crossings to the next block.

State: stable

Losses: not detected

Deterioration: deep flat furrows are cut horizontally on the jamb of the block in a chaotic order; there are also numerous furrows on the surface of the stone, which can be a consequence of the mechanical cleaning with metal brushes. Erosion of the surface of the stone, numerous cavities, cracks, furrows

Cracks: seven large deep cracks (the biggest cracks are on the jamb of the block all over its height, as well as between the first and the second ribs over the block's height), numerous small and big cracks, which can lead to destruction and chipping off part of the block.

Contamination: yellow spots, black patina, a part of the cement additions between the block the entrance door is in black, red and green colour

Panels: four alabaster panels of different colour – yellow, green, white

Additions: cement additions on the ribs of the block near the junction of the eleventh and the tenth blocks over its breadth; all ribs in the lower part are supplemented with cement mortar, also a gap between the entrance door and the block; grouted joints and cracks. Cement additions fissure and come off the stone, cracks in the cement are filled with cement mortar again. There are as well cement mortars with different content of impurities

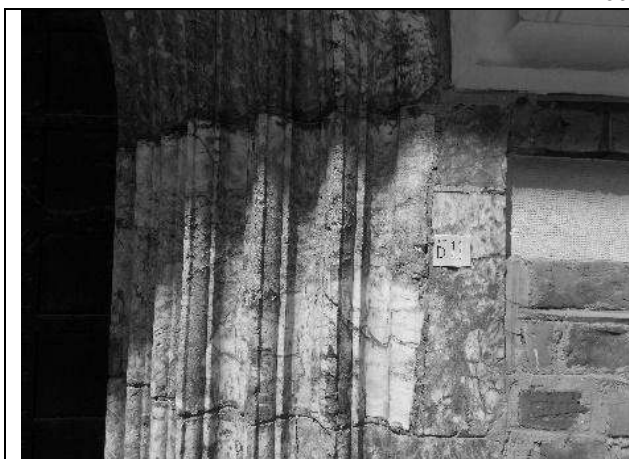
Block No. 11

Alabaster molding block, consists of five ribs

State: unsatisfactory

Losses: not detected

Deterioration: stone stratification, mechanical damages, numerous splits, deep flat furrows are cut horizontally on the jamb of the block in a chaotic order, there are also numerous furrows on the surface of the stone, which can be a consequence of the mechanical cleaning with metal brushes. Erosion of the surface of the stone, numerous cavities, cracks, furrows

Cracks: six large deep cracks, which can lead to chipping off considerable part of the block. Numerous minor and small cracks.

Contamination: yellow spots, black patina, a part of the cement additions between the block the entrance door is in black, red and green colour

Panels: five alabaster panels of different colour – white, grey

Additions: three small cement additions on the ribs of the block, as well as between the entrance door and the

block; grouted joints and cracks. Cement additions fissure and come off the stone, cracks in the cement are filled with cement mortar again. There are as well cement mortars with different content of impurities
--	--

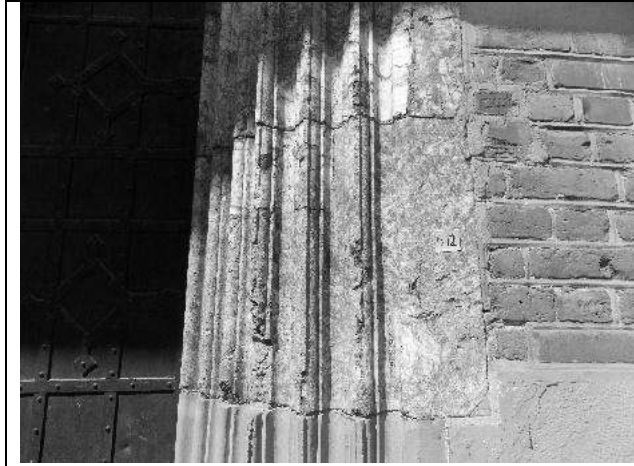
Block No. 12

Alabaster molding block, consists of five ribs

State: unsatisfactory

Losses: considerable part of the fourth rib of the block is lost. A part of the ruined block (the fourth one) was supplemented with the alabaster panel, which is lost as well. There are preserved marks of panel mounting: four hewn rectangular chamfers and cement mortar on which the panel was fixed. A little fragment of the third block is lost too.

Deterioration: stone stratification, mechanical damages, numerous splits, deep flat furrows are cut horizontally on the jamb of the block in a chaotic order, there are also numerous furrows on the surface of the stone, which can be a consequence of the mechanical cleaning with metal brushes. Erosion of the surface of the stone, numerous cavities, cracks, furrows

Cracks: four deep cracks, the biggest one is on the jamb of the block and follows all over its height

Contamination: yellow spots, splashes of green and red paint, a part of the cement additions between the block and the entrance door is in red, green and black colour.

Panels: four alabaster panels of different colour – grey and white

Additions: a gap between the entrance door and the block, joints between the blocks, cracks and splits are filled with cement mortar

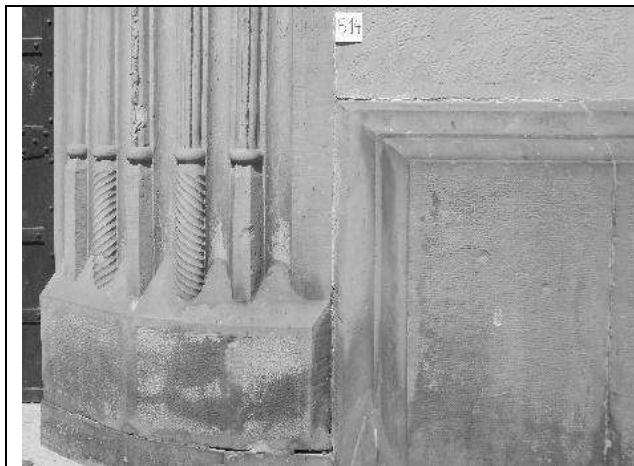
Block No. 13

Result of the restoration work: four square planes with a transition to the molding body of the portal. Profile of the ribs looks like an astragal. There are six ribs. The bead moldings have a prismatic and curved form. The square planes of the block have a bush-hammered decoration with fluted arrises.

State: satisfactory

Losses: not detected

Deterioration: small splits and cavities

Cracks: one crack between the cement addition and the stone

Contamination: black patina, splashes of black and red paint, cement mortar on the rib of the profile. Small spots of orange and red colour, which resemble the spots of rust. The yellow and white spots caused the dampness of the stone. Cement additions are in green colour.

Additions: a gap between the block and the entrance door all over the height of the block filled with cement mortar; grouted joints, cracks, cavities. Cement additions fissure and come off the stone

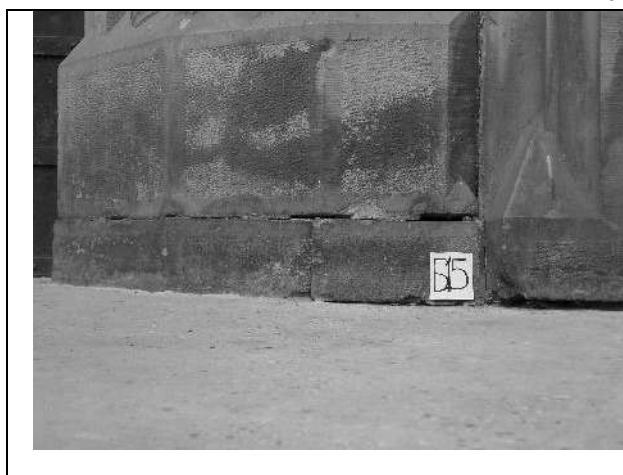
Block No. 14

Result of the restoration work: Four stone rectangular planes, which follow the angle of the portal, are made of sandstone. The surface finish of the stone looks like a bush-hammered plane with fluted arrises.

State: satisfactory

Losses: decorated surface finish of plinth is partly lost

Deterioration: one of the plates comes off the plinth; small splits; weathering of the stone, yellow and white spots.

Cracks: not detected

Contamination: black patina

Additions: a gap between the block and the entrance door all over the height of the block filled with cement mortar; grouted joints, cracks, cavities.

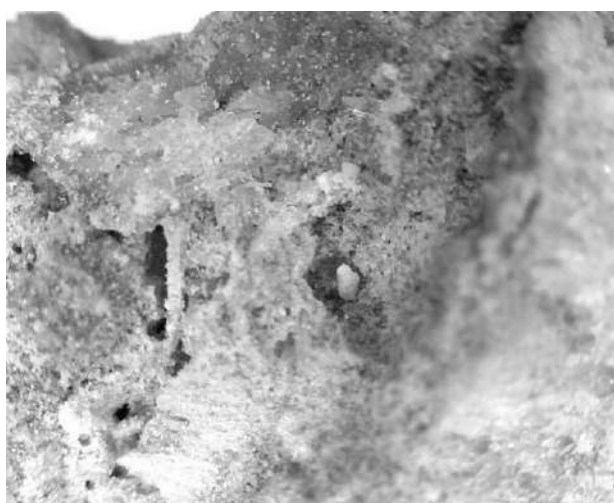
Fig. 5. Block 11. Sample XV. Clearly outlined structure of the alabaster crystals. Finely crystalline structure. Small content of clay impurities and veins of fibrous selenite

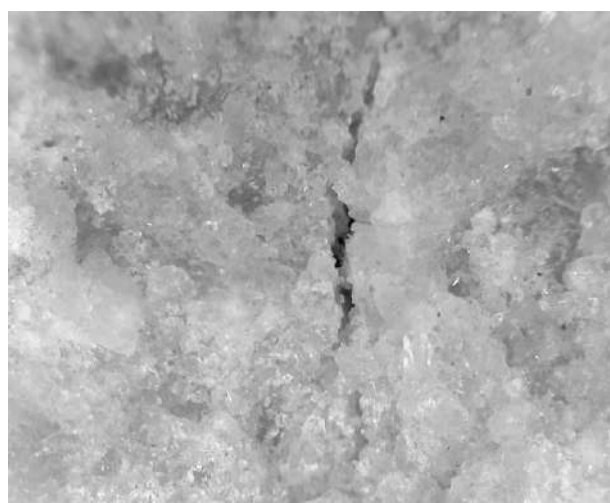
Fig. 6. Block 7. Sample XI. The process of water erosion and void formation was observed, which caused the cracks in the stone

The reasons of deterioration are, first of all, weather conditions: rain, sudden temperature change, sun, wind. Microanalysis showed that the structure of the authentic alabaster is finely granular with the gypsum crystals, intercalation of clay layers, fibrous selenite, and iron oxide. The alabaster stone is not covered with any hydrophobic mortars, which could prevent water penetration. Rain, sun and wind cause weathering and stratification of stone. Water, which gets between the alabaster crystals washes them out, and consequently cracks and furrows emerge. The sudden temperature change, freezing and melting of water in the cracks lead to the increase in their number and size.

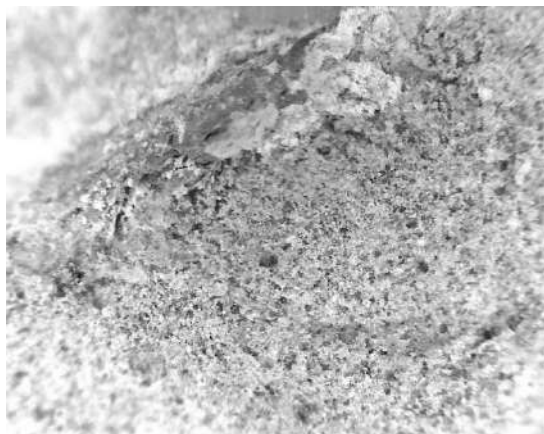
The cement mortars differ from each other by the ratio of binding agent and component composition: brick, sand, gypsum, lime (Fig. 7–8).

Fig. 7. Block 6. Sample IX. Lime and sand content is bigger than cement content. Mortar structure is porish

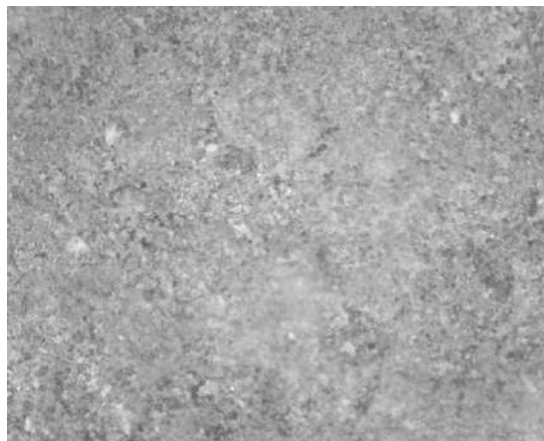
Fig. 8. Block 1–2. Sample XIX. Impurities of brick powder and lime
