**Vol. 1, No. 2, 2015**

## **THE PALACE AND GARDEN COMPLEX IN WŁODOWICE. PROSPECTS FOR RESTORATION AGAINST OTHER TOURIST ATTRACTIONS OF THE KRAKOW-CZESTOCHOWA JURA**

**Abstract.** The article analyses potential restoration of a historic park and palace complex in Włodowice. It discusses the pragmatics of preservation in conservation practice. Furthermore, the author suggests possible courses of action designed to bring clarity to the original layout of the complex and popularize the commune as a tourist attraction.

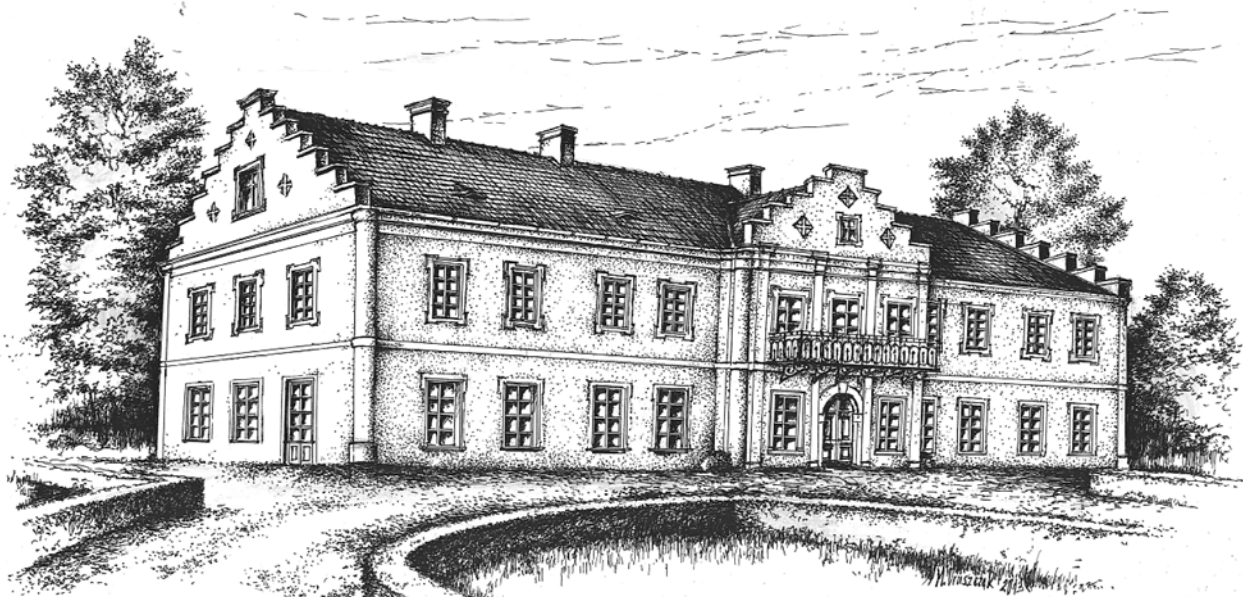
Fig 1. Drawing of the palace

The palace is in the form of ruins with preserved front wall and several rooms on the ground floor. They are all completely demolished, flooded by water and covered with vegetation, which is a serious threat to the ruins. Roots are disintegrating uncovered walls, deteriorating their condition. The fires have completely destroyed wood elements. What can be only seen now are the places they were originally embedded. Out of the four chimneys, two have survived to this day but their top parts have fallen apart. Cast-iron railing on the front wall of the building is the last surviving trace of the old balcony.

1) Structural protection together with supports for slanted walls and vaults. Possibly in some cases, it may be necessary to rebuild the latter.

2) Maintenance of the crenellation, by protecting it against water penetration and filling all cavities to prevent water accumulation. It will be often necessary to rebuild 1–3 layers of bricks in order to introduce horizontal insulation.

3) Restoration of the external face of the wall by repairing joints, filling in deeper cavities and reinforcing the structure. It all requires great care with regards to the final visual result.

4) Implementation of a drainage system, which will increase the stability of the ruins. Rainfall, low temperatures and lying snow have been mainly responsible for wall devastation. Therefore, properly designed drainage with correct gradients and rainwater channelling will slow down the destruction processes.

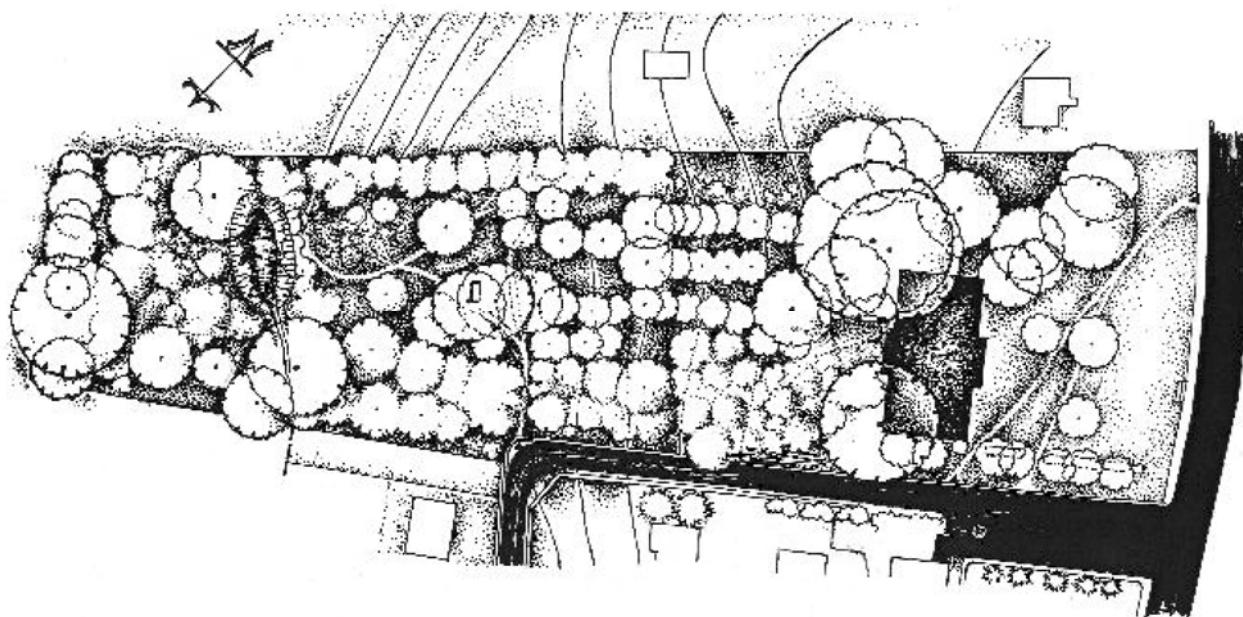
**Fig 2.** Vegetation scheme of the park

It is difficult to point out a dominating tree species, yet the majority of them are deciduous trees. There are a number of trees typical for historic parks, such as maples, lindens, hornbeams and ashes. These are located closer to the palace, whilst in the lower part of it, fruit trees can be also found: apple, pear and plum trees<sup>8</sup>.

The bush layer is represented by jasmines, lilacs, hazels and forsythias. They grow mainly in groups, but are also scattered around the park as a result of chaotic self-seeding. The existence of original hedgerows can be confirmed by the presence of privet. We can assume that the park had flower hedgings. The remnants of hornbeam rows suggest that the park had bosquets [7]<sup>9</sup>.

However, without being properly taken care of, the plants almost completely “took control of the park” so that it is sometimes difficult to penetrate the thicket of trees and bushes. This is best seen within several meters from the palace and in the water reservoir situated slightly below the palace. The reservoir is completely shadowed as a result of the expansion of self-seeding vegetation.
