Architectural-archaeological research and the hypothesis of the development of pre-local Drohobych in the XII-XIII centuries

Abstract. Architectural and archaeological studies of preserved architectural monuments emphasise the continuity of development, succession, and originality of the culture of each nation. The research aims to highlight the results of architectural and archaeological surveys at the foundations of the wooden architectural monument – the Church of the Exaltation of the Holy Cross in Drohobych, as well as to develop the hypothesis of the city’s urban genesis. According to the analysis of literary sources, seven construction periods have been identified since the church was built in 1613. The sounding method showed that the first foundations were standards, which were installed in pits on the cut surface of the continent, often with stone slabs, and covered with soil. The system of double slabs fixed under the altar crown of the log house is considered archaic. During the third and fourth construction periods, some of the stands were replaced, and a stone foundation supported by a wide base of slabs was built under the northwestern corner of the main log cabin. I

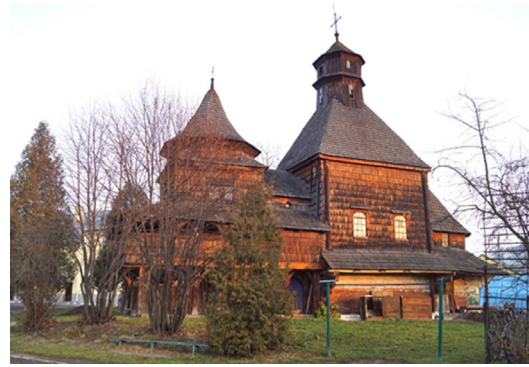
Figure 1. A general view of the Church of the Exaltation of the Holy Cross in the Zvarytske suburb of Drohobych from the southwest

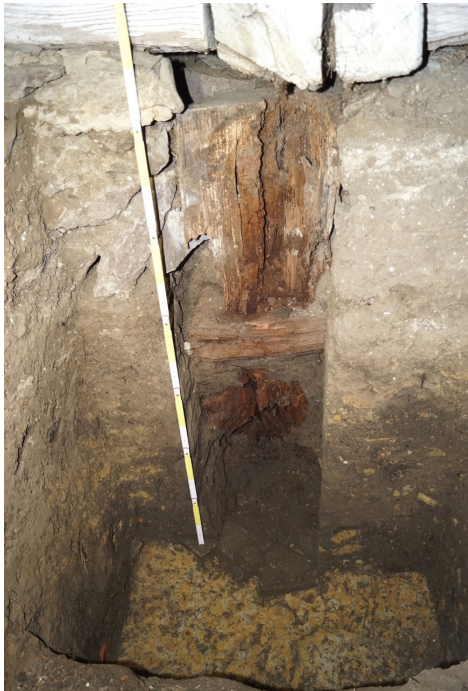
Figure 3. Probe 1 is at the final stage of opening.
View from the south, from above

Stander 1, a round timber with a smoothly chopped end surface, without bark, semi-rotten, and heavily cracked in the longitudinal direction, was found just under the crown of the log cabin. Loose soil took the place of the rotted or dried wood areas. Stander 1 was supported on transverse bedding made of a 10 cm thick and ~24 cm wide piece of board. The board is located parallel to the southern footing, i.e., in an east-west direction. The western edge of the substrate board is evenly cut off, corresponding to the designed contour of the stander, and the eastern edge extends beyond the opening. The length of the substrate was determined using a feeler gauge to be ~58 cm. Therefore, stander 1 was supported on one side of the substrate without a groove for fastening. During the operation of the structure, the western side of the substrate settled and the fragment of the substrate board itself tilted by ~10° from its original position (Fig. 3; Fig. 4). The sagging of the base board indicates that the stander was performing its support function before the brick foundation was built, and after the strip foundation was installed, the drying of the stander wood led to a gap of 5-8 cm between its upper end and the foundation (Fig. 3; Fig. 4).

In the north-western corner of the probe, the foot of a part of the ribbon foundation of the southern foundation was reached. It was built using a medium-strength grey lime-sand mortar of flaked dense sandstone and granite. There are no layers in the masonry. There are no traces of grouting between the stones. Most likely, the structure was built from the opposite, inner side of the building. The width of the foundation at the top is about 40 cm, and slightly increases to about 50 cm downwards. The base of the foundation lies at the level of -0.95 m, i.e., the height of its structure is 50-55 cm. The foundation is installed on mixed soil. Judging by the nature of the surface, the structure was built openly. The foundation is laid to stander 1 (Fig. 3; Fig. 4).

During the last restoration in 1970-1971, waterproofing in the form of roofing material was installed between the surface of the foundation and the basement. During this process, the nave timber frame had to be slightly supported. The state of preservation of the foundation above the waterproofing is satisfactory (Fig. 3; Fig. 4).

In the western wall of probe 1, the profile of another pit, dropped into the previous one, can be traced. Its bottom is horizontal, with a mark corresponding to the level of the stone foundation sole (-0.9 m). At a distance of 85 cm from the contour of the foundation, the bottom of the pit turns into a sloping side wall at an angle of $\sim 60^\circ$. The pit fill contains interspersed clumps of lime-sand mortar, which is similar to the foundation fill. On this basis, the pit should be attributed to the time of the church's renovation in 1823, when a stone foundation was laid under it (Fig. 3; Fig. 4).

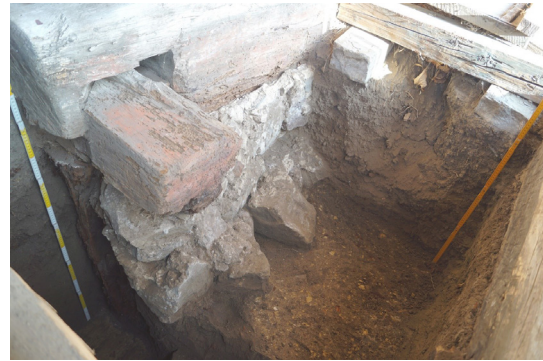
Figure 5. Probe 2 at the final stage of processing.

View from the south-west, from above

former wider dig. At the level of -0.85 m, the probe reached the base of the stone foundation (Fig. 5).

The bases are connected by an interesting hidden oblique lock. The upper part of the cross-base outlet was lost before the last restoration work, as indicated by its uneven surface, which is covered with red paint as an antiseptic, along with the side face of the longitudinal plane. The fairly evenly chipped crown of the transverse base originally filled the cavity under the upper base's mortise to the top. The end of the upper base is cut with an axe (Fig. 5; Fig. 6).

unsatisfactory. The wood of both foundations in the lower part has rotted to a thickness of 5-7 cm (Fig. 5).

The foundation structure was built in an open-cast manner. The material for the foundation is a dense, crushed grey sandstone, as well as granite, generally pinkish in colour with dark and light angular inclusions of feldspar, quartz, and crystalline mica specks. The stones are of various shapes, mostly with one/several naturally formed or chipped smooth surfaces. The masonry is bonded with a light grey lime-sand mortar. In terms of material and construction techniques, the foundation is similar to the masonry found in Probe 1 (Fig. 5; Fig. 6).

The foot of the foundation is laid much wider than its upper part, by 20-27 cm. The contours of the lower layer are irregular, and its thickness is 18-20 cm. The next layer is built with bedded stones and is 10 cm thick. The third layer, 20 cm thick, consists of sub-cubic stones, which are set in a row almost to the bottom edge of the foundation. The surface of the row was levelled with smaller stones and filled with a layer of mortar, into which the undermined foundation unit was lowered or "drowned" (Fig. 5). The mortar on the outside is often in the form of frozen streaks, without traces of grouting. Thus, the foundation structure was built from the opposite, inner side of the building. A significant number of cavities can be seen on the southern face of the masonry. A characteristic feature that indicates that the foundation was built under existing foundations is that the mortar partially covers the base of the foundation, forming a kind of rim several centimetres high and wide (Fig. 5).

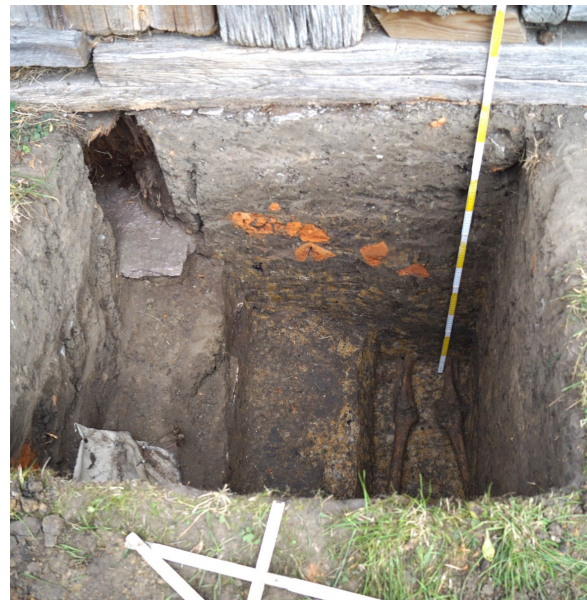
Figure 7. Probe 3 is at the final stage of opening. View from the west, from above

Probe 3 (1×0.8 m) is located at the northern pillar of the main entrance to the lower gallery. Its longer side is oriented in the north-south direction. The probe is adjacent to the foundations of the lower gallery (Fig. 2; Fig. 7).

was found near the northern wall of the burial pit, indicating the presence of a coffin, no traces of which survived. The surface of the mainland horizon was reached in the middle part of the probe at the level of -0.95 m. It is cut off, as the transition between the mainland and the mixed soil is quite sharp (Fig. 7; Fig. 8).

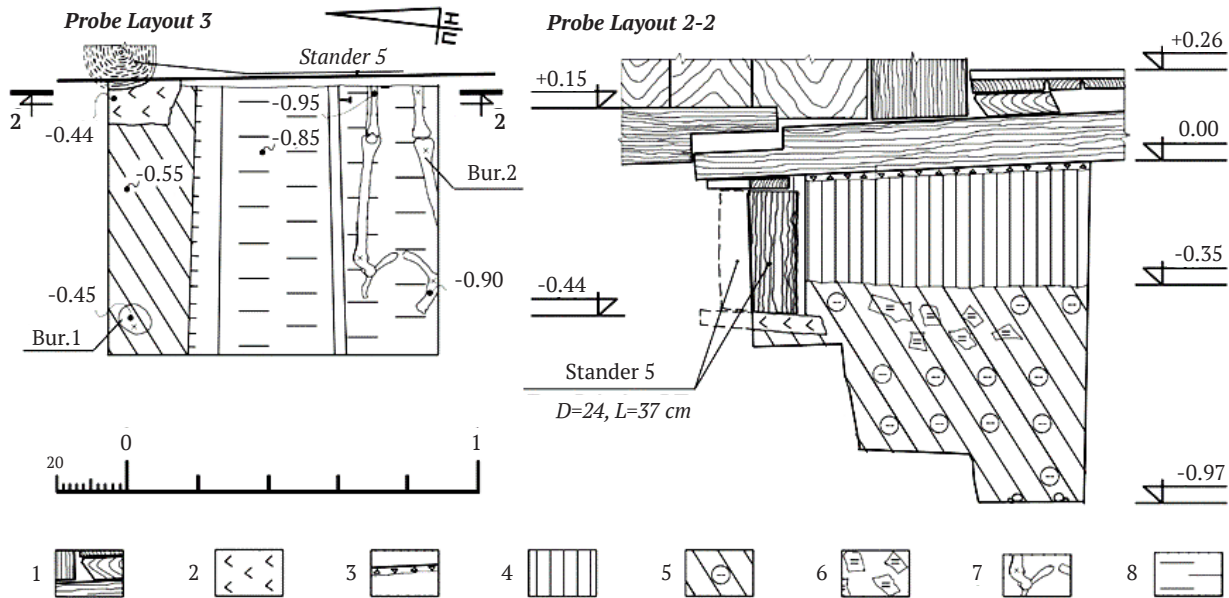
Figure 8. Probe 3. Layout and eastern wall in scale 1:20

Note: 1 – wooden structures; 2 – granite slab; 3 – crushed stone layer; 4 – grey loam; 5 – brown loam with clay; 6 – brick cluster; 7 – human bones; 8 – mainland clay

At the northern wall of the probe, in the north-western corner, at a depth of -0.45 m, a human skull was found – burial 1 (Fig. 8). It was decided not to examine the burial and leave it in place, but to go deeper only in the southern part of the probe to the mainland horizon. At a depth

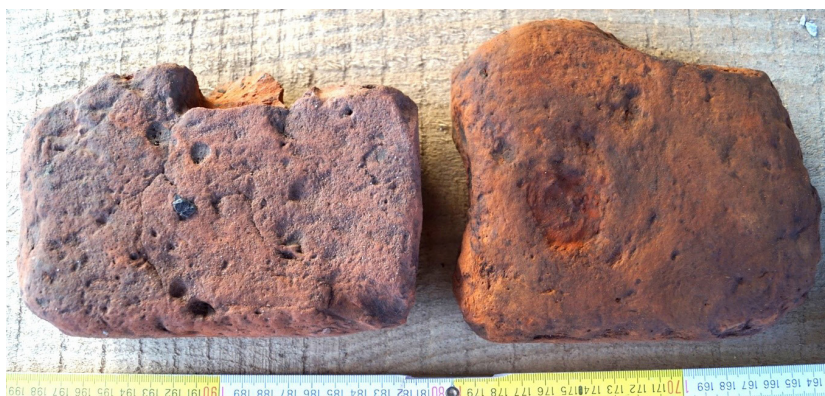
Figure 9. Probe 3. Fragments of two brick floor tiles

Between the marks of -0.350.65 m, a cluster of brick fragments was found, among which two almost intact brick tiles were found. Their format is 16×14×4-4.5 cm. The tiles are completely baked, i.e., well fired. The medium-density

ceramic dough contains impurities of quartz sand, especially on the lower and side surfaces. The upper bed of the tiles is quite convergent, i.e., smoothed by friction. They come from a ceramic floor that has been in use for a long time (Fig. 9).

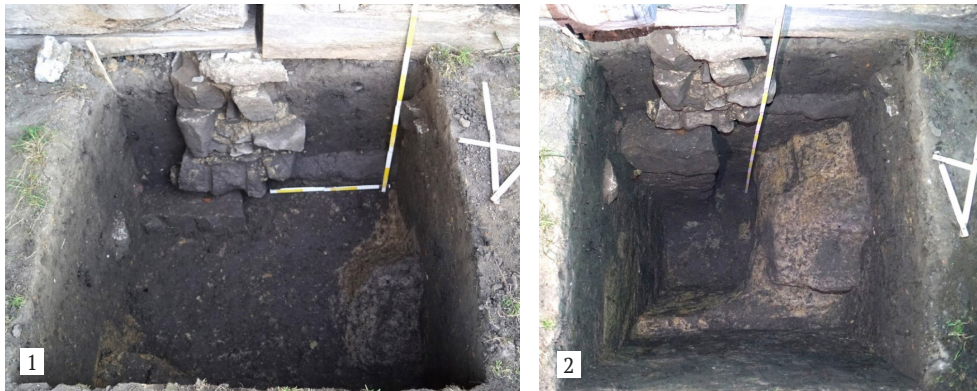
Figure 10. Probe 4

Note: 1 – stripping at the level of 0.6 m; 2 – the final stage of opening, view from the north, from above
Source: author's photo

the log house, a part of the masonry foundation supported by two wide slabs was uncovered, and at the final stage of excavation within the probe it turned out that the slabs were installed over the filling of a deep pit (Fig. 10; Fig. 11).

processed stones with knees and naturally flat surfaces. The fourth layer is made up of a single bedded limestone, which is slightly different in structure from those used for the foundation, although it may also belong to the original masonry, as a seam filled with “native” mortar has been partially preserved under it, and fragments of the same filling can be traced on its upper bed. At the same time, another lime-sand mortar of a greenish hue was observed on the surface of the stone, on which a sheet of roofing material was installed and supported by a new restoration base in the form of a rough board, added from below the old one. These are traces of the 1971 restoration of the monument (Fig. 10).

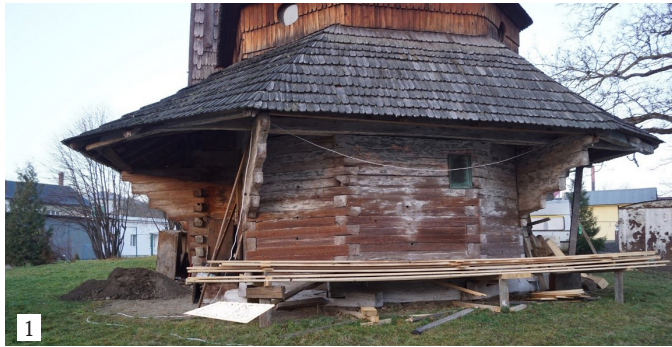
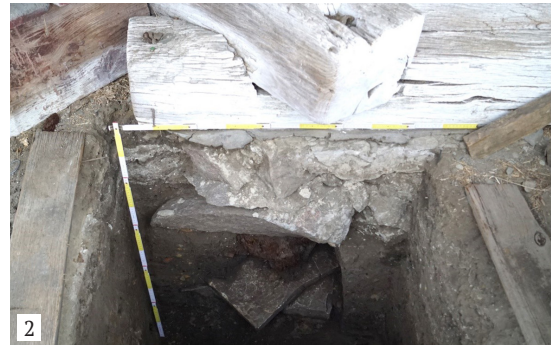
Figure 13. Probe 5

Note: 1 – the location of the probe, viewed from the east; 2 – a fragment of the combined stone and wood foundation structure under the altar log, viewed from the southeast

Probe 5 was carried out at the foundations of the first southeastern bay of the altar log. The probe area of 1×1 m was oriented at an angle of 45° to the cardinal points, i.e., exactly coincident with the broken face of the altar log (Fig. 2; Fig. 13, 1).

The stone masonry completely covers the remains of stander 6, the upper part of which was destroyed during the foundation laying. The diameter of the stander is 30 cm, and its surviving length is 22 cm. It is similar to standers 2 and 3 in terms of its state of preservation and wood character. The base of the stander consists of two tiers of cream-coloured sandstone slabs. The upper slab (45×40×4 cm) is installed in line with the side foundation, and the lower slab (60×24×12 cm) is installed along the direction of the broken foundation. In other words, the slabs are arranged in a similar sequence to the foundations (Fig. 13, 2).

horizon belongs to an earlier period. It is evenly mixed due to the church necropolis, the objects of which can be found below (Fig. 13, 2).

On the south-western side of the probe, a light layer of redeposited lime-sand mortar is visible from above, which should also be linked to the construction of the foundation in 1823. Above it, a layer of clay lock has been preserved. The foundation pit did not extend into this area. It could have been occupied by the structures of one of the levers used to raise the altar log. From the level of -0.45 m in the right (western) part of the wall, the sloping contour of the pit leading under the crown of the log house is visible. Most likely, this is a pit for the construction of stander 6. It is filled with brown loam mixed with grains of yellow mainland clay and brick fragments. Above this pit, the fill of which was still relatively loose, the construction layer just mentioned is settling (Fig. 13, 2).
