DOI: 10.56318/as/1.2025.84

Olena Stasyuk*

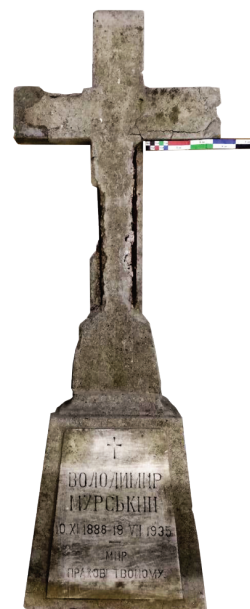
Figure 1. Reinforced concrete tombstone cross of the Volodymyr Murskyi view before restoration
Source: authors' photo

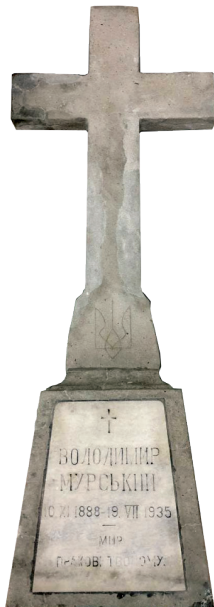
Figure 2. Reinforced concrete tombstone cross of the Volodymyr Murskyiview after restoration

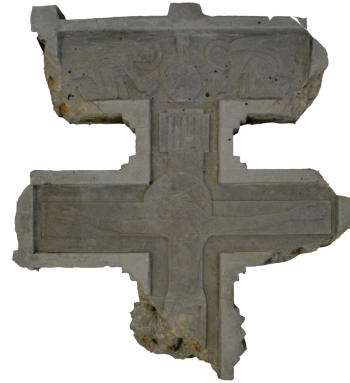
Figure 3. Memorial reinforced concrete cross from the Saint Assumption Univ Lavra museum's collections before conservation

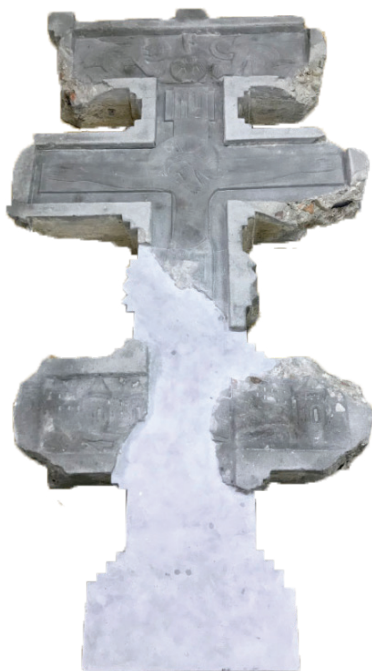
Figure 4. Memorial reinforced concrete cross from the Saint Assumption Univ Lavra museum's collections after conservation

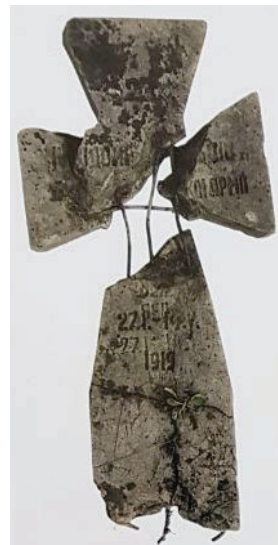
Figure 5. Reinforced concrete cross rifleman of the Ukrainian Galician Army from the city of Belza before the conservation
