THE THEORY AND HISTORY OF ARCHITECTURE

Mykola Bevz

**PAINTING DECORATIONS ON THE OUTSIDE WALLS
OF THE CASTLES IN POMORIANY AND IN YAZLIVETS**

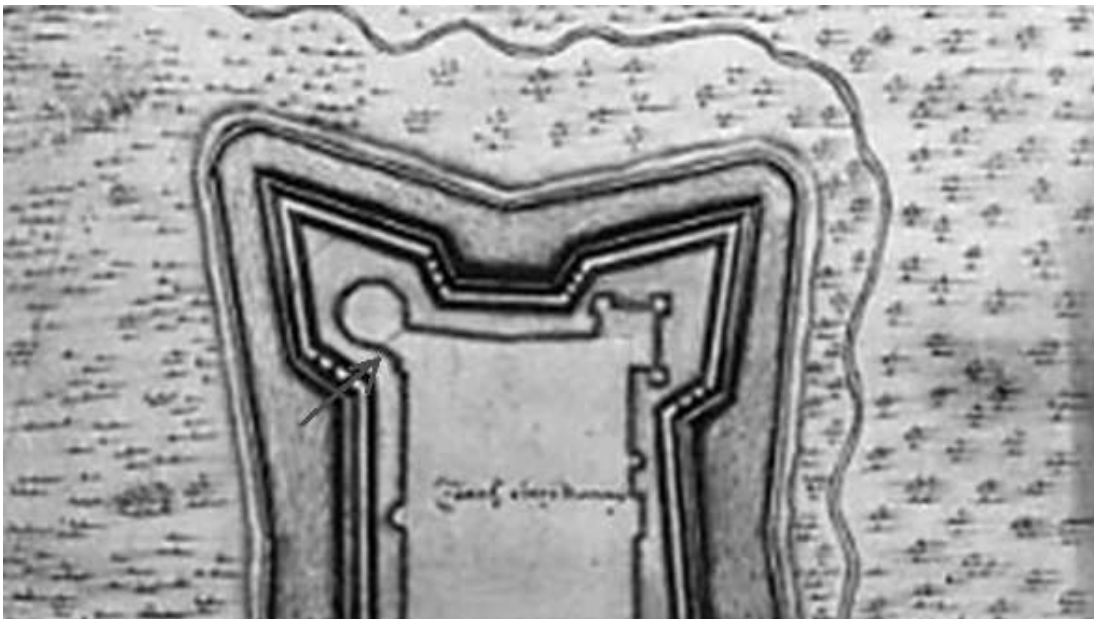
Fig. 2. Drawings of the fortifications of the Pomoryany castle taken from the work of Alexander Cholovsky.

In the northeast corner, a round tower with facets is marked. The western wall we are exploring is a preserved part of the “neck” to this tower. This wall is marked by an arrow

The preserved ruin presents features of Renaissance architecture with a tall frieze in arcade-style. A careful analysis of the preserved walls shows that these renaissance building forms are not the oldest. They create a newer substance based on older walls, which were built of pieces of stone and had firing ranges in the form of a key for hand-held firearms. We hypothesize that the attic completion of the tower is newer and imposed on older walls (see Fig. 4). An in-depth study of the history of the Pomoryany castle by Alexander Cholovsky contains a very valuable plan for the castle complex of the 18th century. On the plan, the tower has a layout scheme in the form of a five-angled defence building, reminding the typical scheme of the “punte” tower. Comparison of the tower plan in A. Cholovsky’s documentation (Fig. 2) with the modern plan (Fig. 3) indicates that the three outer walls of the tower were not preserved. Two walls (north and east) were completely lost, and a small fragment remained from the third one. The foundations of the former pentagonal tower have been preserved in the ground and can still be identified today by the topography of the relief.

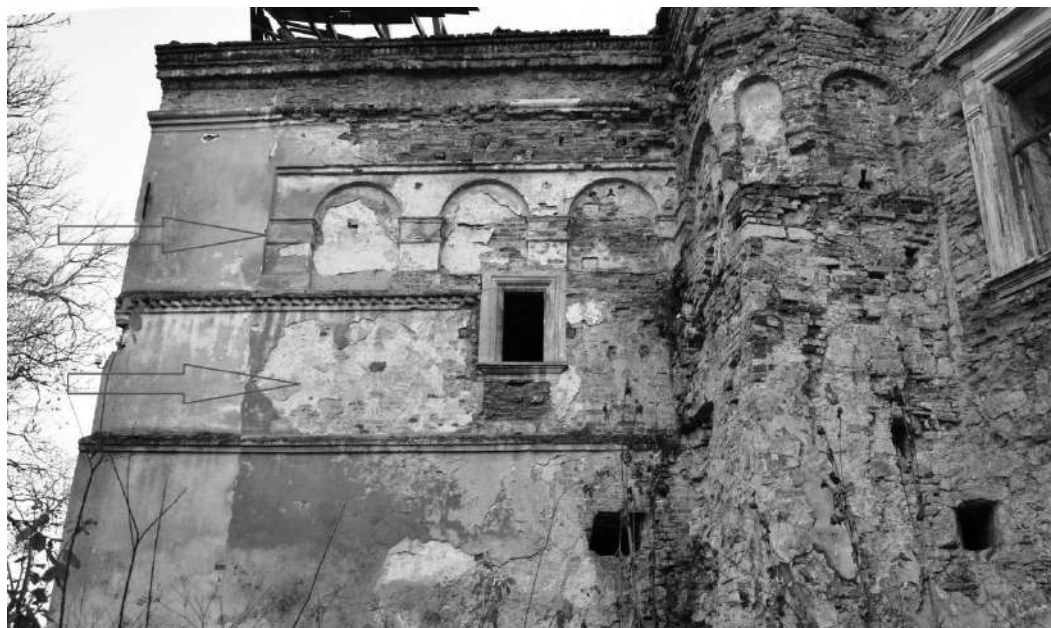
Fig. 4. The north wall of the corner tower of the Pomoryany castle.
The places where the polychrome paintings preserved are indicated with arrows

The paintings were at the height of the second and third tiers on the outer wall of the southeast corner tower (Fig. 1). This tower has been preserved in its reconstructed form. Its northern wall is best preserved and features Renaissance style with the remains of a “blind” arch belt over which, apparently, once had an attic end (sketch at Fig. 2). Nowadays the upper part of the tower has a cornice end that is dated to the time of the rebuilding of the castle under Jan III Sobieski. The bricks and the eaves are similar to those parts of the castle

that are identified with the times of reconstructing of the castle to the royal palace. The lower part of the tower is made of broken limestone. This is probably the oldest substance. Therefore, the investigated wall of the tower, according to our hypothesis, has three elements that differ in time of construction. Polychrome paintings adorned the second and third tiers of the facade.

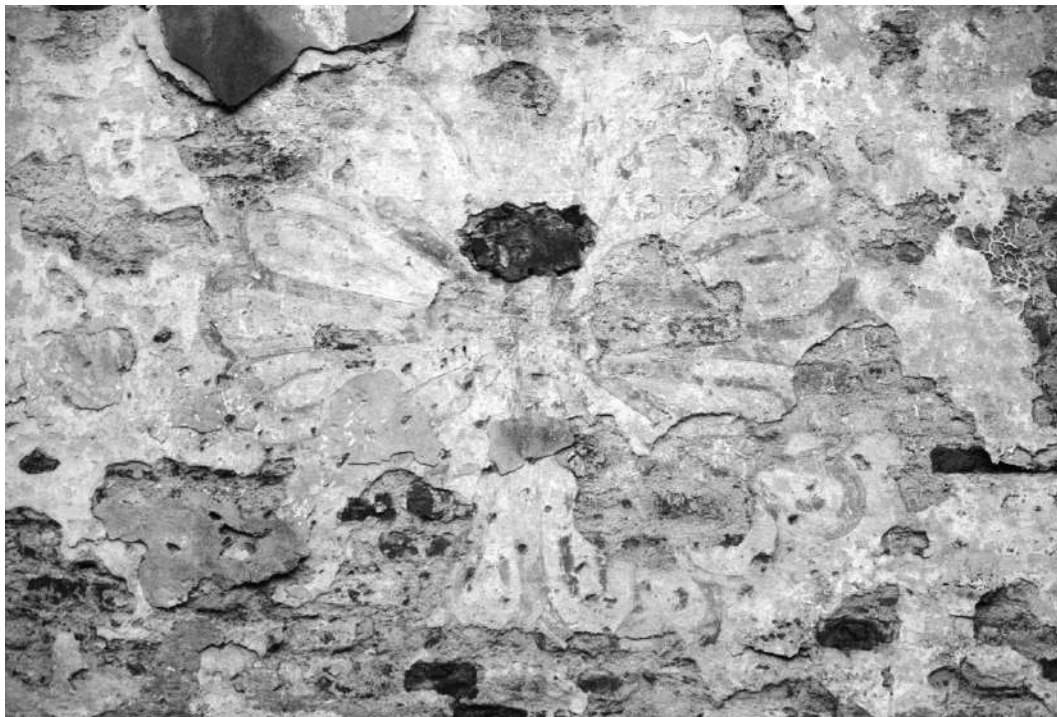
Fig. 5. A large rosette drawn on the 2nd tier of the outer wall of the corner tower of the Pomoryany castle

Red, grey and blue colours dominate in the paintings. The murals are in the state of an emergency. Most of them are lost, although preserved fragments can be used to reconstruct an integral image. The second tier of the tower was painted with rosettes almost two meters in size (Fig. 2), among which were drawn some geometric figures (Fig. 3).

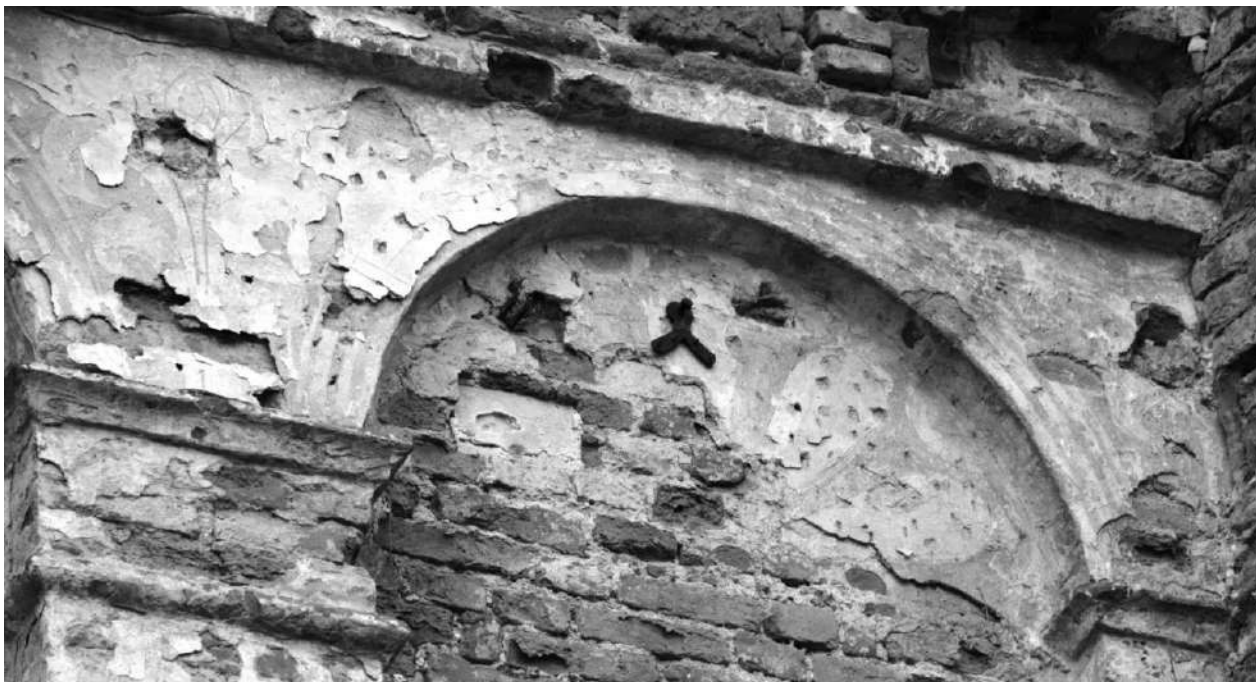
Fig. 7. Hand-drawn archivolts and half-rosettes in the arch belt on the 3rd tier of the outer wall of the tower. On the left side to the arch are fragments of a rose with branches

The third tier of the tower, which was built with a blind arcade, was also decorated with polychrome paintings. Their pattern corresponded to the arcade profiling of the wall. Under the arches were painted half-rosettes similar in style to those found on the 2nd tier (Fig. 4). The pilasters had hand-drawn fluting. Their traces are still barely readable. Above the arches, striped archivolts (at 7 belts) were drawn in detail. The triangular fields between arches above the pilasters are the most interesting: there is a large rose with symmetric branches. 30

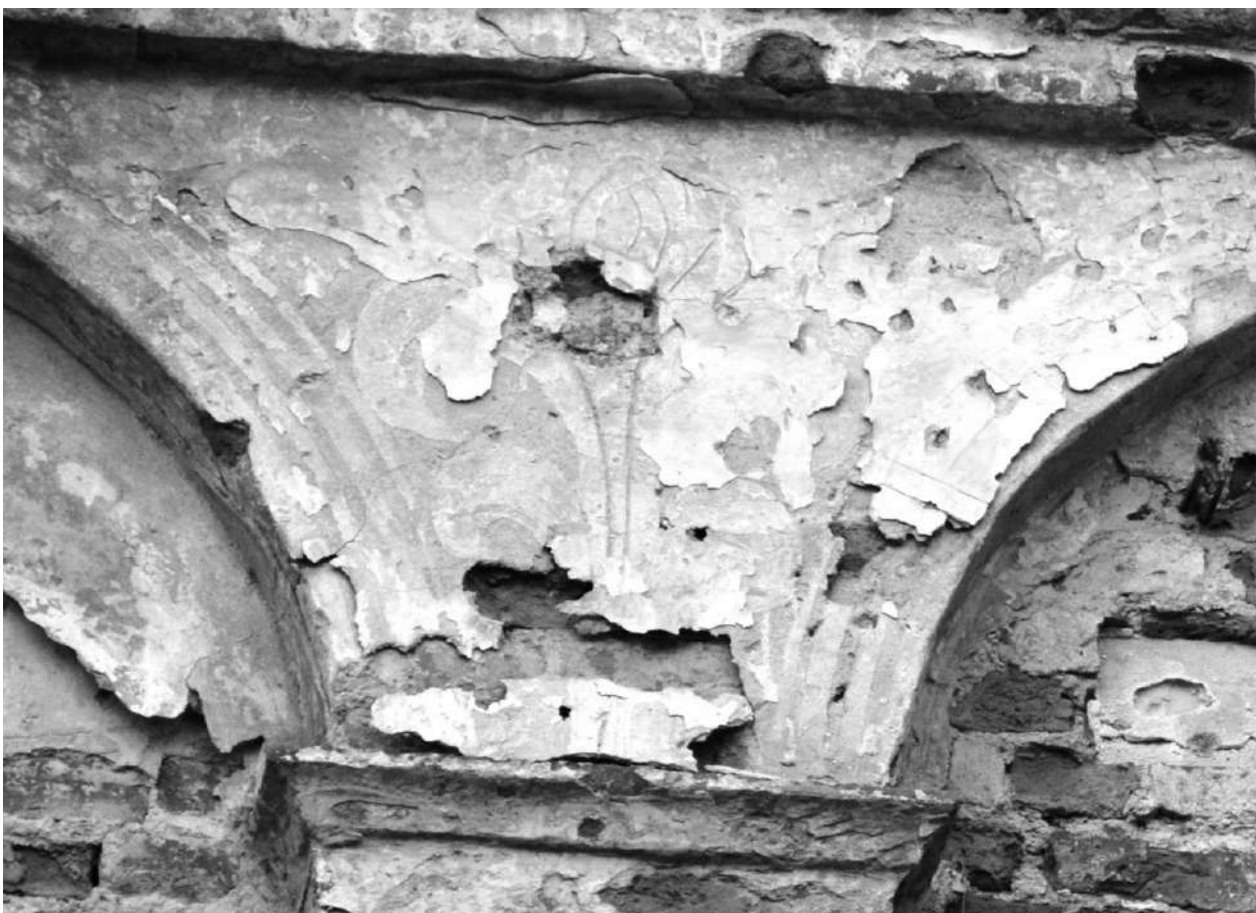
Fig. 8. Hand-drawn rose with branches on the 3rd tier of the outer wall of the tower

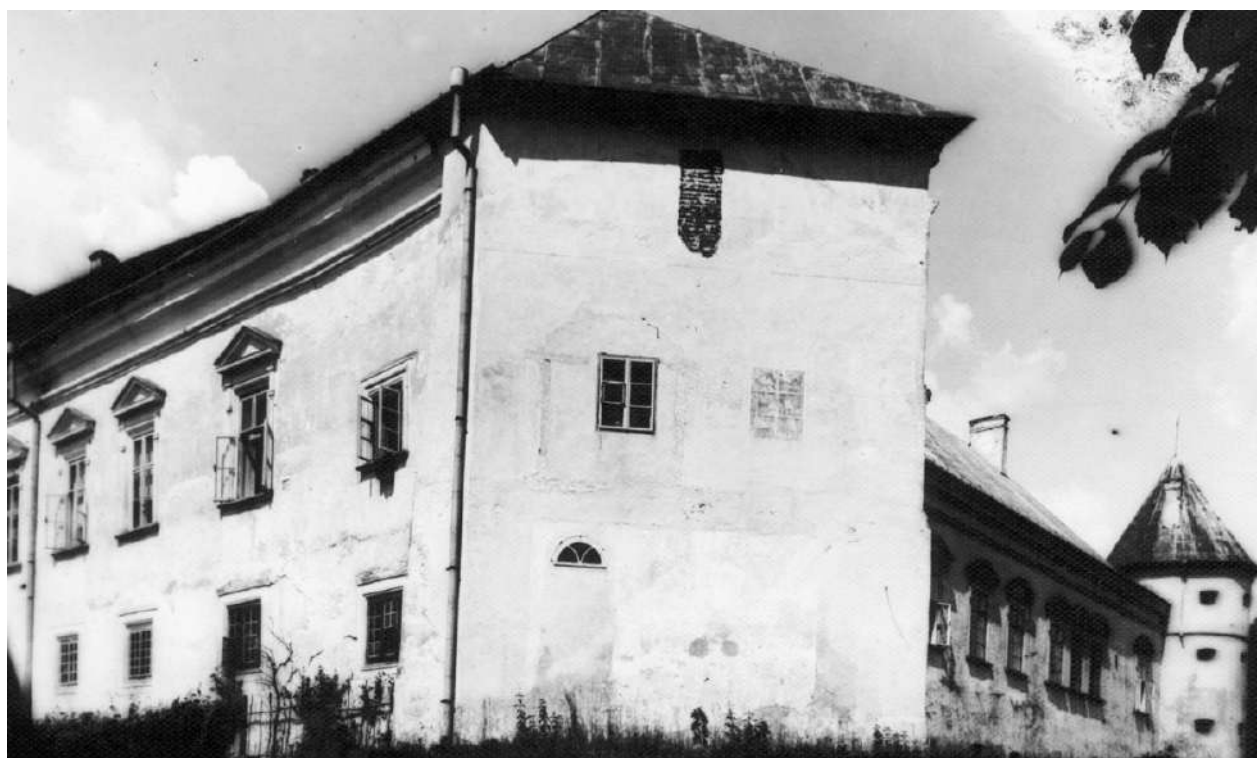
Fig. 9. The castle in Pomoryany. Photo from 1914. The place of the lost octagonal tower

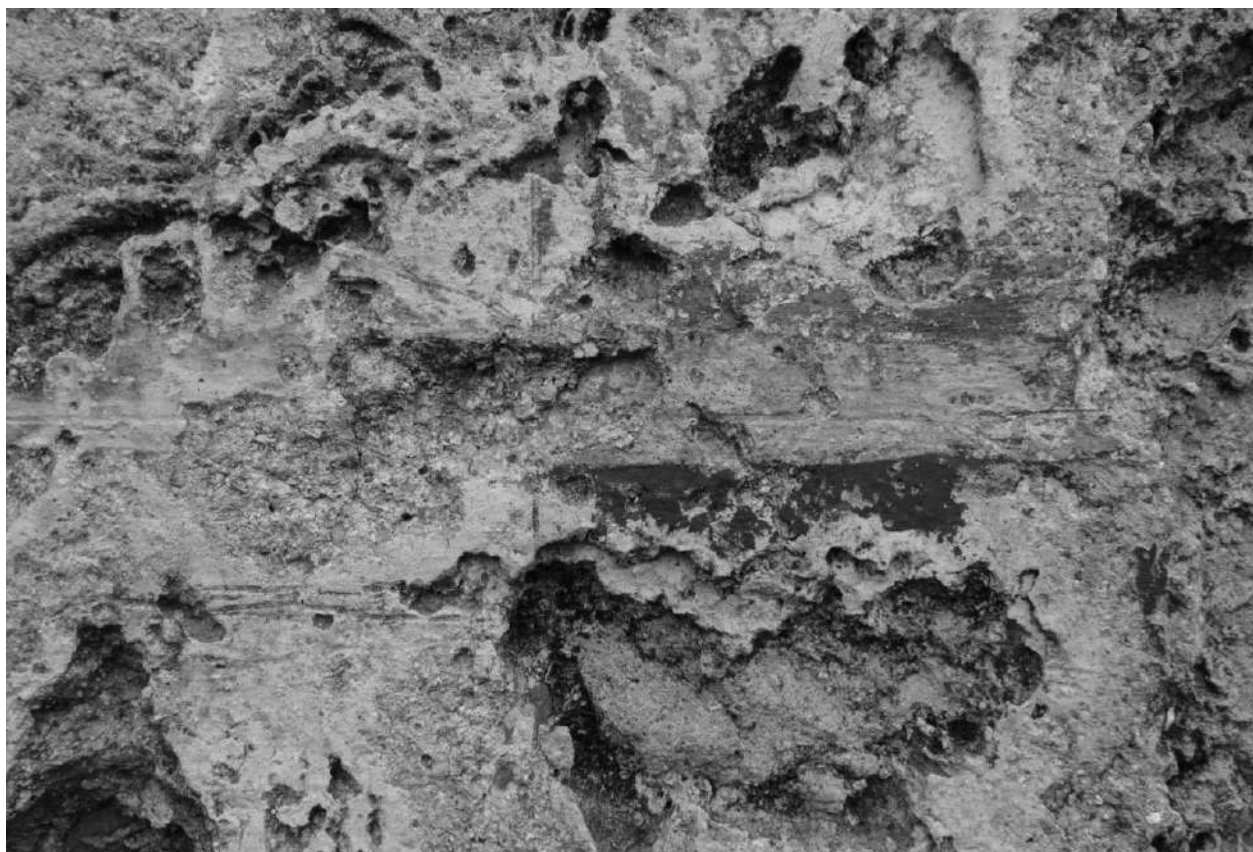
Fig. 11. Fragments of paintings at the outer wall of the castle in Yazlivets.

Unfortunately, only small fragments of polychrome survived, so it is unlikely to reconstruct the decoration. However, all fragments of the preserved plastering of the castle are worth examining in detail to determine the remains of polychrome. The preserved fragment shows a geometric pattern (Fig. 7) in several colours (red, grey, blue, white and ochre). It looks like it was an orthogonal grid of colourful lines that was combined with some other elements of the plant or figurative nature.
