CONSERVATION OF ARCHITECTURAL AND ARTISTIC HERITAGE

**CAUSES OF DESTRUCTION
OF ARCHITECTURAL DETAILS MADE OF ALABASTER STONE.
(FOR EXAMPLE, THE GOTHIC CHURCH IN DROHOBYCH)**

The aim of this study is to define the reasons and the consequences of the deterioration of the gothic alabaster portal of the parish church of St. Bartholomew in Drohobych.

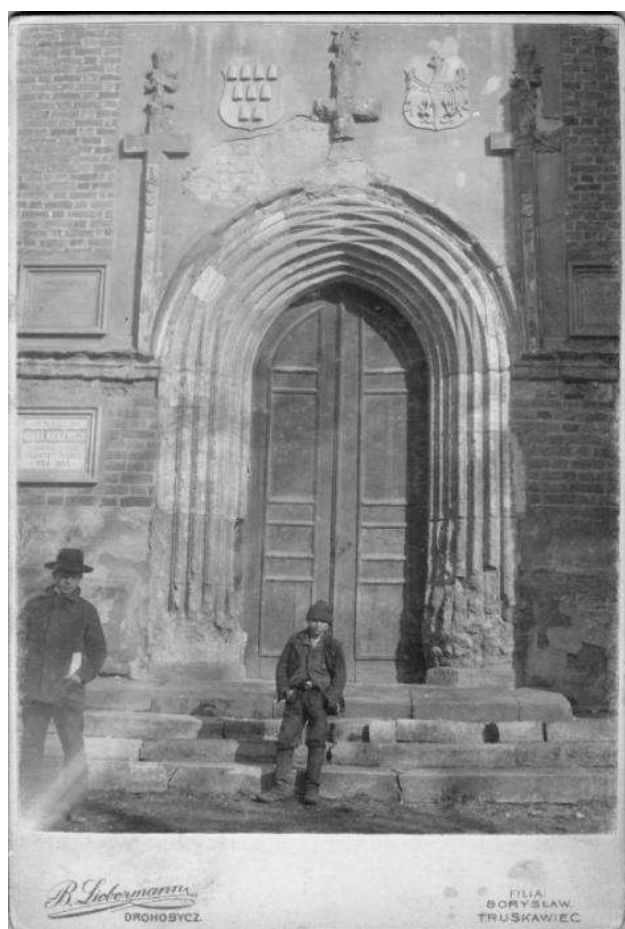
Fig. 3. Drohobych, parish church, south portal.

The gothic alabaster portal is one of the unique architectural features of the church. Its foundation M. Mściwujewski credits with Jan Mężyk (chief – starost – of Drohobych), who supported the building of other entrance portals on the south and north sides of the church. The research of Felix Gątkiewicz gives some facts about the once oak double leaf doors and the poor state of the portal, which was literally falling apart into pieces (Gątkiewicz, F. Z., 1906, p. 9). Today the oak doors are replaced with the metal doors. The photograph taken by B. Lieberman in 1906 before the reconstruction is the visual confirmation of Gątkiewicz's words (Walczak, W., Lopatecki, K., 2013, p. 318] (Fig. 3). In the picture, you can clearly see the damaged lower part of the portal,

now reconstructed from sandstone. Unfortunately, it is impossible to define the authenticity of the reconstruction. You may as well see the elements of the alabaster panels made before 1906. The staircase was laid out of stone and was considerably narrower than nowadays. Information plaques were relocated to the buttresses. There is the surface of plaster with two crosses and coats of arms of Drohobych and Poland above the alabaster portal. M. Mściwujewski poetically unfolds the history of these two crosses origin, which is related to the name of Jan Mężyk (chief – starost – of Drohobych). In the eighteenth century, swords were replaced with crosses; in the center, one more cross, smaller in size, was hewn; the coat of arms of Drohobych substituted the J. Mężyk’s one. According to M. Mściwujewski, Jan Mężyk commemorated the most significant day in his life – the participation in the Battle of Grunwald (July 15, 1410), which the two swords along the edges of the portal symbolize. “Therefore, he decided to tell the descendants about the triumph of the Polish and Lithuanian troops and his own participation in it, and ordered the architect to hew out of stone two huge Teutonic swords over the doors, the coat of arms of Poland and his own, and the inscription: “Hoc templum ineuntes Deus benedict – memento animi” – “Bless God all those who enter this shrine – remember the soul” (Mściwujewski, M. V., 2018, p. 4).

Photo by B. Lieberman, 1906. Photograph collection of the Institute of the History of Arts UJ (repr. W. Walanus) (Walczak, W, Lopatecki, K, 2013.p. 318)
