Lucjan Gazda¹, Mykola Bevz²

**MATERIALS AND ARCHITECTURAL DETAILS
FROM NATURAL AND ARTIFICIAL STONE OF KING DANIEL
ROMANOVICH'S XIII CENTURY RESIDENCE IN CHOLM**

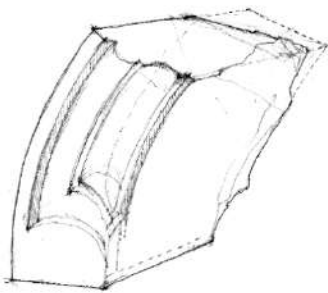
Table 1

№	Description of details	Drawing of details	Material and dimensions of the detail
1	2	3	4	5
Stone architectural details from the archaeological studies	1	Fragment of archivolt of arch. The face is profiled with a quarter fillet, half roll and base

An interesting is a glauconitic block with two sloping surfaces on the long side (Table 1; p. 8). The smooth upper rectangular sanded surface indicates that it is an element of a granular column or a rounded vertical wall. The scorched layer on the face confirms this, indicating that the block was interior.

- The largest group is the profiled corner blocks with a half-roll (there are 8 in Pokryshkin excavations and 7 new); (p. 4–6 in Table 1);
- Another group is profiled blocks with quarter fillet, half roll and vertical rods (1 new block and 3 blocks in Pokryshkin's collection); (p. 7 in Table 1);
- Curvilinear blocks with quarter fillets (three found); they were part of the archives of the perspective portal arch.

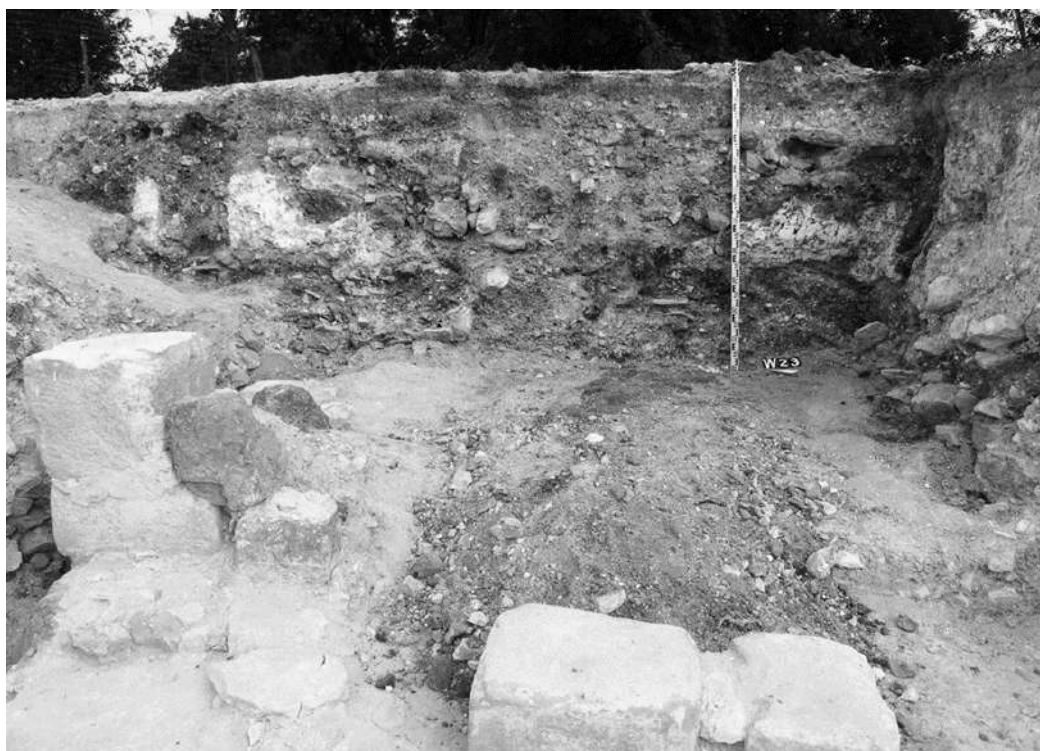
The materials obtained from the eastern profile of excavation no. 23 were subjected to analysis, where the object of distinctly outlined rectangular shape and vague purpose was initially documented (Fig. 2, from the left), which is accompanied by intentional accumulation of chalk (Fig. 2, from the right). This object is located beyond residential arrangements at the east bank. Archeologically, they can be dated for the 2nd or 3rd functioning phase of Daniel’s residential and sacral complex, after the destruction of outer walls and raising the ground level, so after the fire from 1256.

Fig. 2. Eastern wall of trench no. 23 within the residential and sacral complex at Wysoka Gorka in Cholm (photo S. Golub). Retort synthesis of limestone from chalk (left) and chalk raw material (right)

The samples from the object, which were operationally called as retort (Fig. 2, from the left), were taken to the research. At the upper part of the object, there is little modified white and grey chalk (Fig. 3, *a*), below light white and grey raw material, harder and more compact than chalk, with distinct replicas of plants stems of segment structure and longitudinal ribs. These replicas have the form of longitudinal negatives as well as longitudinal and transversal cross-sections of stems and leaves of plants morphologically corresponding to a horsetail (*Equisetum* L.) (Fig. 3, *b*). The organic substance has not been preserved. Inner and bottom parts of retort are filled with hard, structurally homogeneous (microcrystal) light grey and white material, cracked of distinct shell and an irregular sharp-edged burring fracture (Fig. 3, *c*).

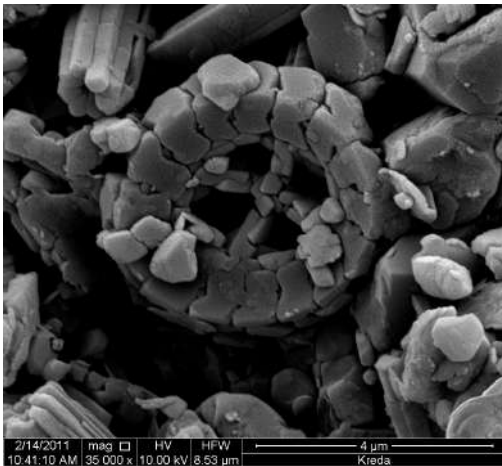
Cholm writing chalk is a typical loose biocalcarenite of dominating hole saw bioclasts in its structure (Fig. 5). In mineral terms, it is a pellicle calcite (above 95 % of CaCO₃) with an insubstantial admixture of loamy minerals, quartz and iron sulphides. It is a soft rock, subject to liquification after adding water and prone to be molded in the plastic state.

Fig. 5. Biomorphic structure of Cholm chalk writing in the image of scanning microscope

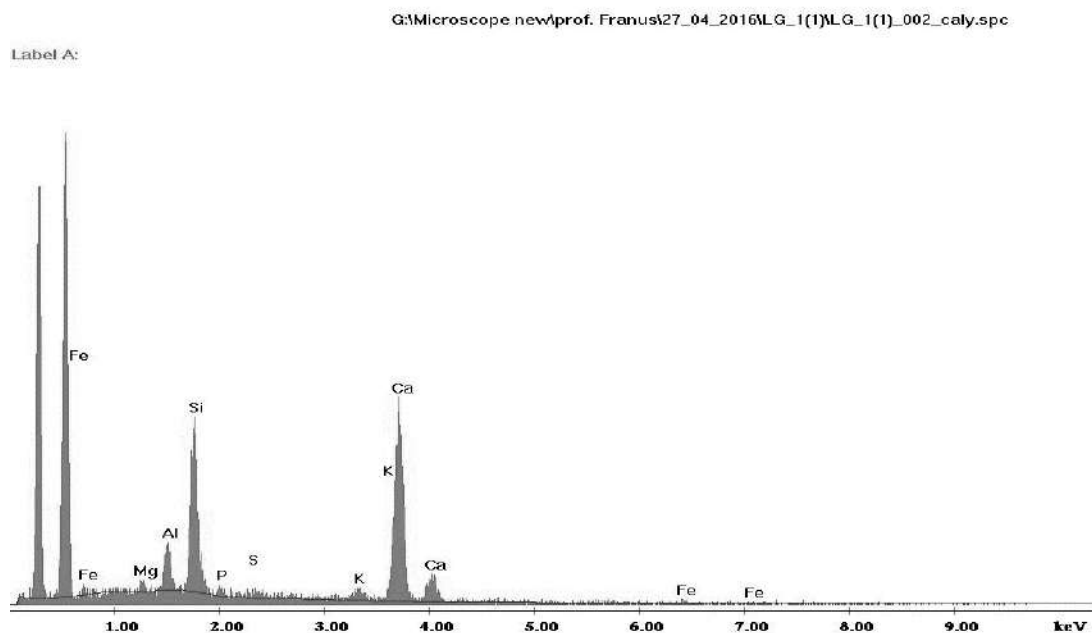
In the chemical content of this material, a considerable increase of silica share is noticeable (Fig. 7).

Fig. 7. Results of chemical analysis of EDS SEM plastic with replicas of horsetail stems

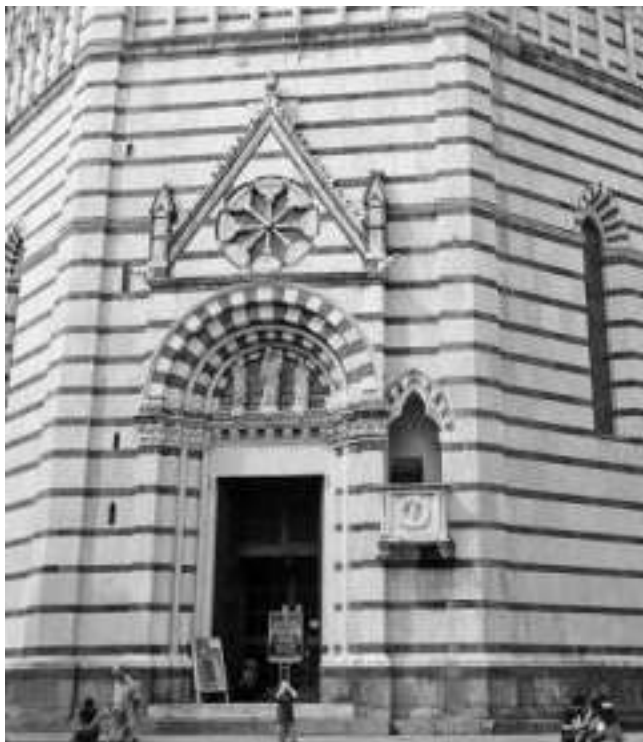
Fig. 12. Baptistery in Pistoia. Main entrance with green and white stone decoration. Photo Lorenzo Lovato

The model for green and white buildings created here before the fire in 1256 as well as the attempts to recreate them, was the implementation of co-called Pisan School from the 12th century but in other architectural forms (Fig. 12, 13).
